TO: ALL BIDDERS  
PROJECT: ITB PW 66-21 – College Road Bypass Bridge (No. 574132)  
Repairs

**Inspection/CIDR Report with PDF attachment(s)  
(INTERIM INSPECTION REPORT)**

Structure ID: 574132

STRUCTURE NAME: Not recorded  
YEAR BUILT: 1997  
SECTION NO.: 57 507 001  
MP: 1.619  
ROUTE: 00000  
FACILITY CARRIED: College Rd Bypass  
FEATURE INTERSECTED: Turkey Creek

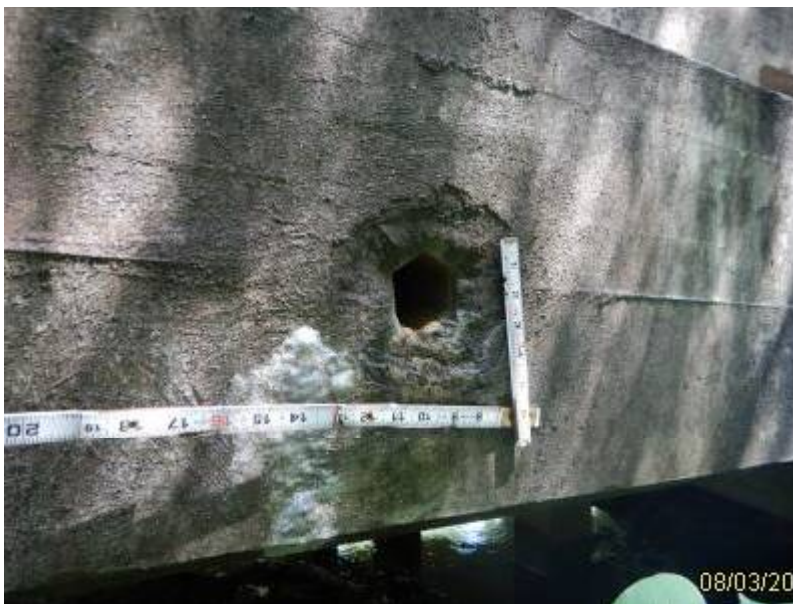
**Photo 1 - Element 8099 PS Conc Slab (Sonovoid)**

- 8099/2      CONDITION STATE 4  
NO CHANGE:  
1) The following spans have missing or broken post-tensioning bars (See Photos 1 and 2) (194SF):  
Span 5, 1 rod missing  
Span 8, 2 rods missing  
Span 9, 1 rod missing  
Span 22, 1 rod broken  
The NBI rating of a 3 for SIA Items 58 Deck and 59 Superstructure is due to direction given by FDOT Central Office.

Missing post tensioning bar in Span 5

REPAIR RECOMMENDATION:

Spans 5 8 9 and 22; replace post tensioning bars.

Replace post tensioning rods in Spans 5, 8, 9, and 22.

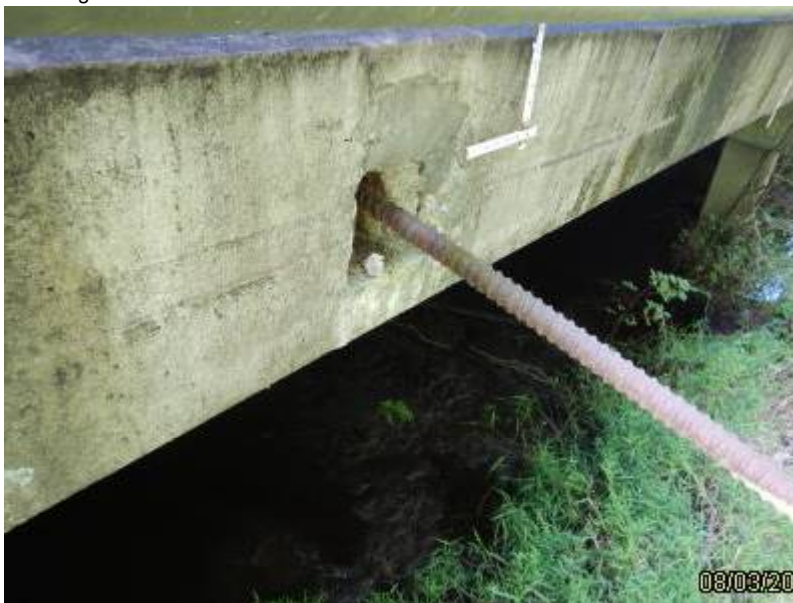
**Photo 2 - Element 8099 PS Conc Slab (Sonovoid)**

Broken post tensioning bar in Span 22

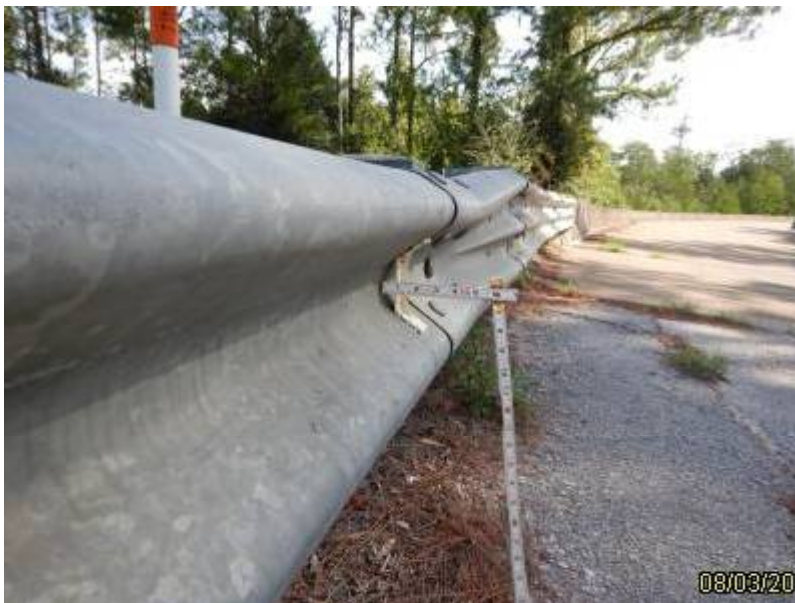
**Photo 3 - Element 8099 PS Conc Slab (Sonovoid)**

- NOTES  
NO CHANGE:  
1) There are signs of active water leakage between the slab units with light efflorescence.
- 2) The approach guardrail reflectors are damaged or missing (See Photo 3).

Typical missing reflector at near left guardrail

**REPAIR RECOMMENDATION:**

Approach guardrails; replace missing and damaged reflectors.

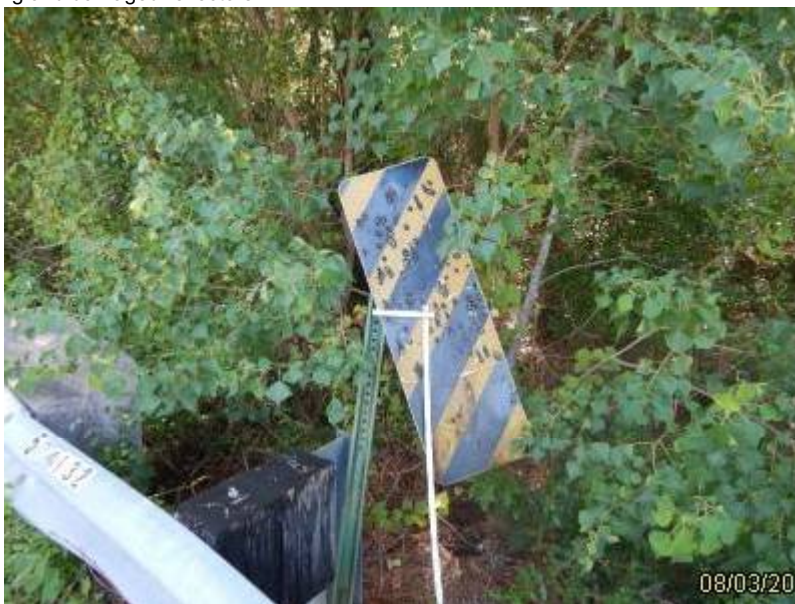
**Photo 4 - Element 8099 PS Conc Slab (Sonovoid)**

- 6) The near right object marker has been damaged and no longer defines the roadway (See Photo 4).
- 7) The near right and far left approach guardrail end terminals have been damaged (See Photo 5).

Damaged near right object marker

**REPAIR RECOMMENDATION:**

Near right object marker; replace.

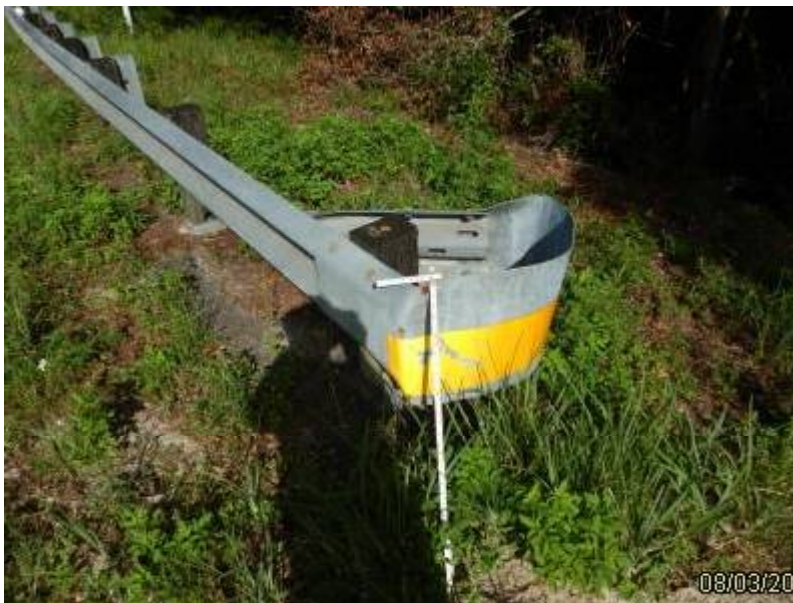
**Photo 5 - Element 8099 PS Conc Slab (Sonovoid)**

Typical damaged guardrail end terminal

**REPAIR RECOMMENDATION:**

Near right and far left approach guardrail end terminals; repair or replace.

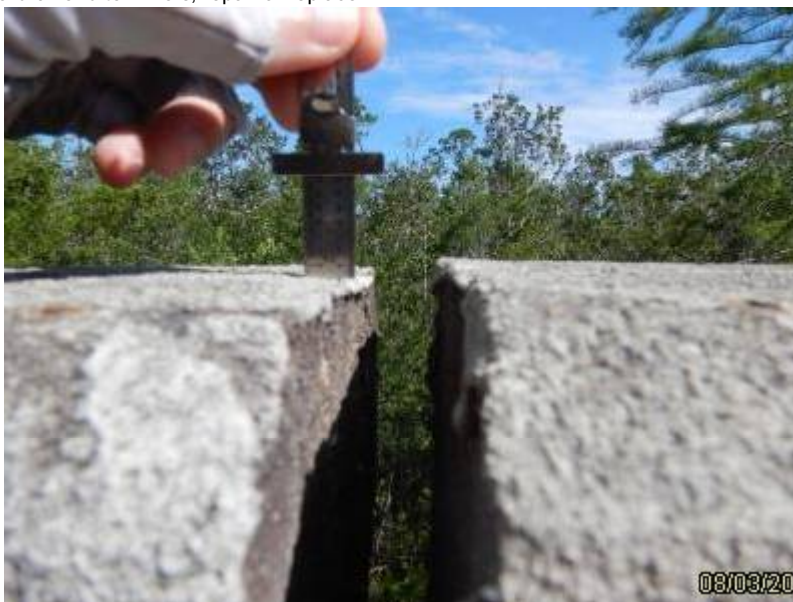
**Photo 6 - Element 8099 PS Conc Slab (Sonovoid)**

- 8) Spans 6 and 7, 12 and 13, 18 and 19, 24 and 25, 29 and 30, 35 and 36 and 42 and 43, are showing signs of vertical and lateral offset with spalls, up to 4ft. L x 0.33ft. W x 0.17ft. D, at the joints with the joint material upheaving and becoming displaced due to the ends of the slab units and bridge rails moving into one another. The measurements to calculate future movements have been established in the bridge rails with orange spray paint at the noted locations within Table 1 (See Photos 6, 7, 8 and See Table 1).

Bridge rail vertical alignment at Bent 5

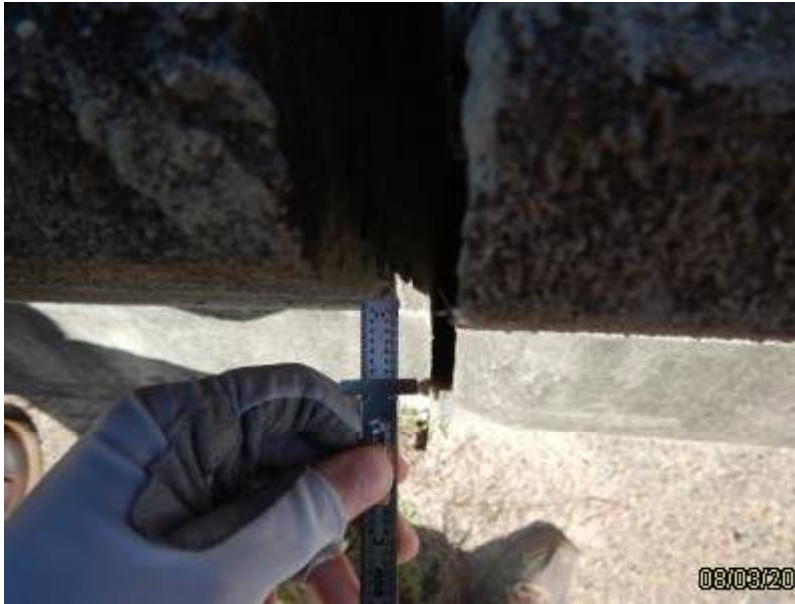
**Photo 7 - Element 8099 PS Conc Slab (Sonovoid)**

Horizontal misalignment at Bent 5

REPAIR RECOMMENDATION:  
None

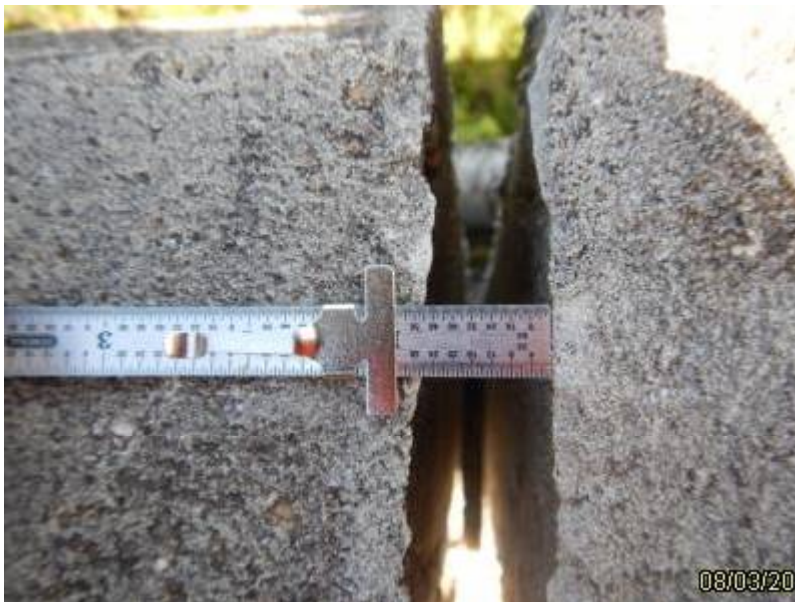
**Photo 8 - Element 8099 PS Conc Slab (Sonovoid)**

Bridge rail offset at Bent 5

REPAIR RECOMMENDATION:  
None

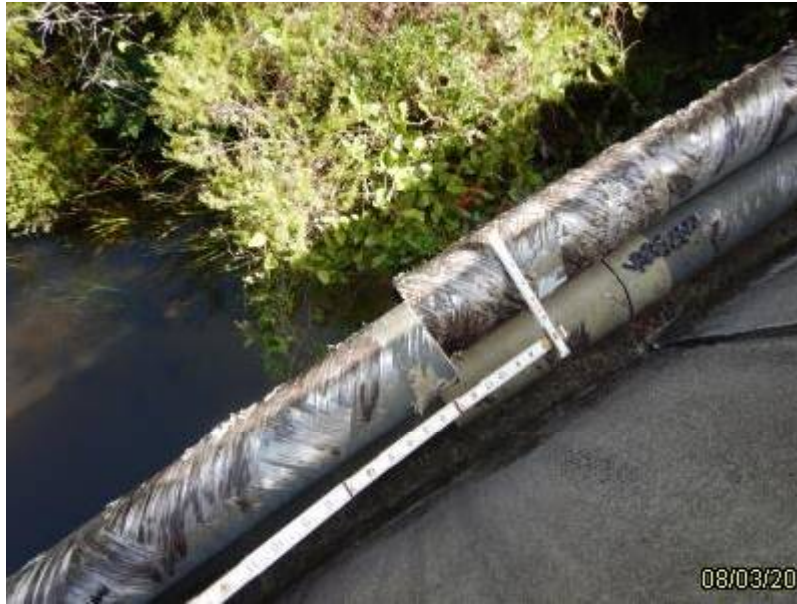
**Photo 9 - Element 8099 PS Conc Slab (Sonovoid)**

- 9) The dual lines of conduit along the left side of the barrier has a broken coupling over Bent 18 at the creek (See Photo 9).
- 1100/2      Refer to Parent Element

Disconnected conduit over Bent 18

WORK ORDER RECOMMENDATION: Conduit over Bent 18; repair or replace.

REPAIR RECOMMENDATION:  
Conduit over Bent 18; repair or replace.

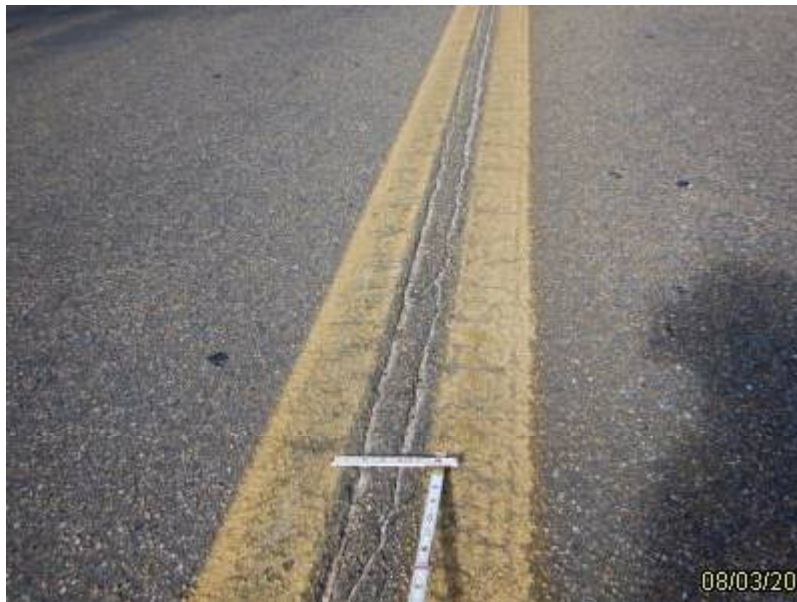
**Photo 10 - Element 8099 PS Conc Slab (Sonovoid) (510 Wearing Surfaces)**

1) The asphalt overlay has longitudinal cracks, up to 0.25in. wide, that coincide with the precast deck units (See Photo 10). (3822SF)

Typical cracks in the asphalt overlay

REPAIR RECOMMENDATION:  
Deck; resurface.

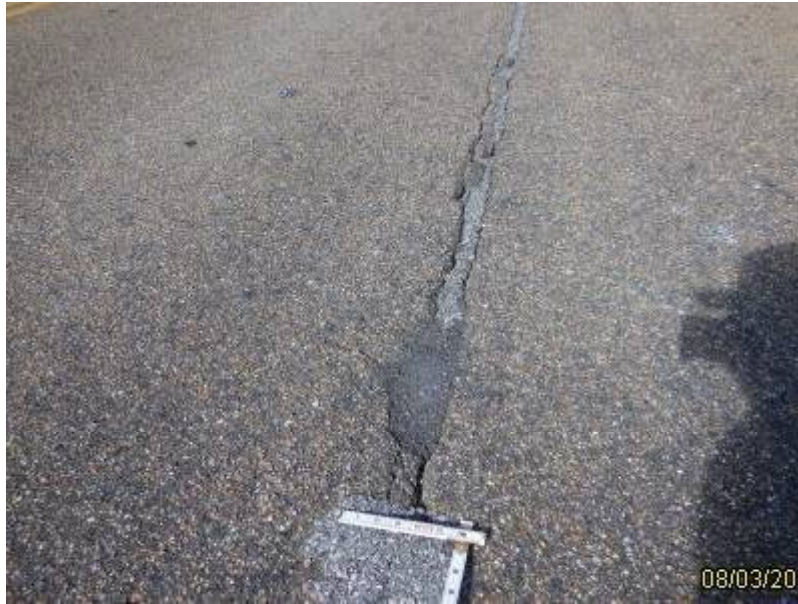
**Photo 11 - Element 8099 PS Conc Slab (Sonovoid) (510 Wearing Surfaces)**

2) There are areas of asphalt breaking up, 4ft. L x 2ft. W x 0.08ft. D, and potholes have formed along the longitudinal cracks (See Photo 11). (476SF)

Typical longitudinal crack with the asphalt breaking apart

REPAIR RECOMMENDATION:  
See Photo 10.

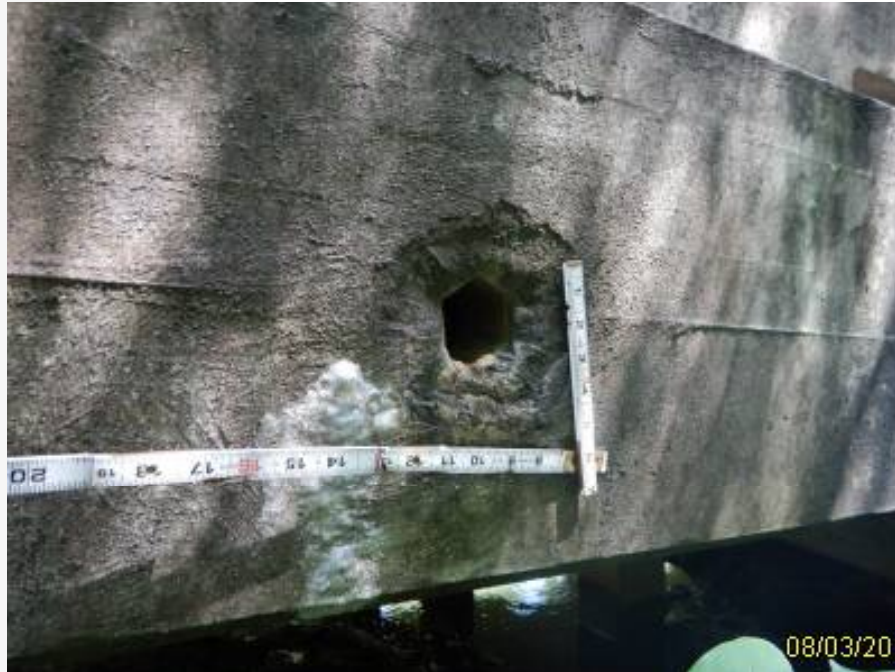
CS4 – The following spans have missing or broken transverse post tensioning bars (See Photos 1 and 2):

Span 5, 1 missing bar  
Span 8, 2 missing bars  
Span 9, 1 missing bar  
Span 22, 1 broken bar

Photo 1 – Missing Post Tensioning Bar in Span 5

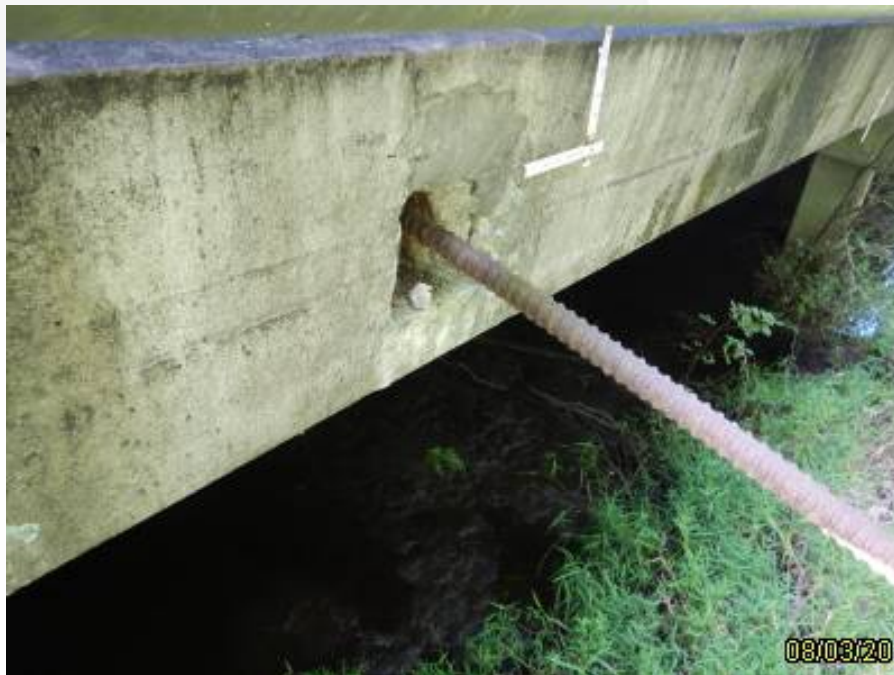
Photo 2 – Broken Post Tensioning Bar in Span 22

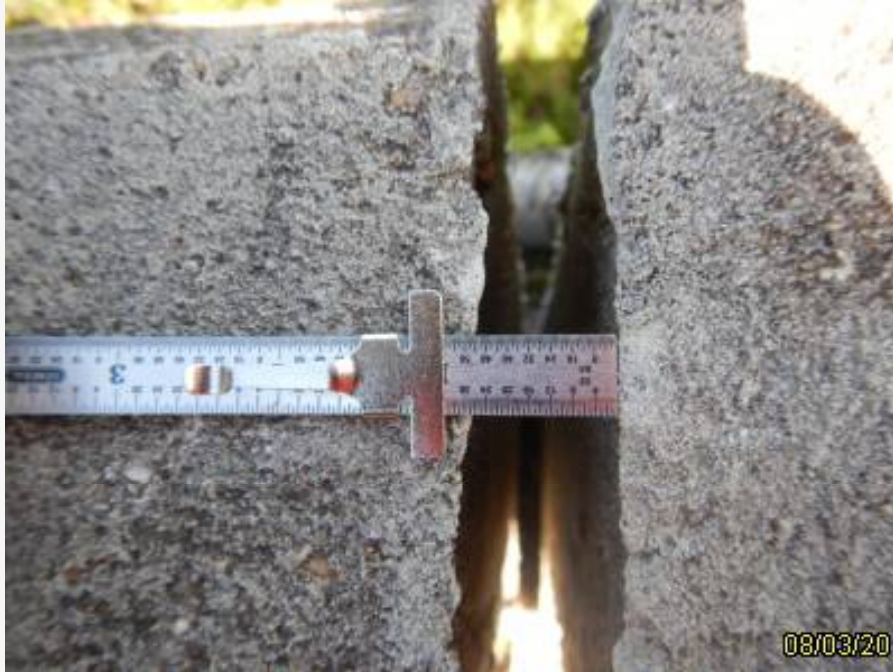
Note – Spans 6 and 7, 12 and 13, 18 and 19, 24 and 25, 30 and 31, 35 and 36 and 42 and 43, are showing sign of vertical and lateral offset with spalls up to 4ft. L x 0.33ft. W x 0.17ft. D at the joints, with the joint material upheaving and becoming displaced due to the ends of the slab units and bridge rails moving into one another. The measurements to calculate future movement have been established in the bridge rails with orange spray paint at the noted locations within Table 1 (See Photos 3, 4, 5 and See Table 1).

Photo 3 – Bridge Rail Offset at Bent 8

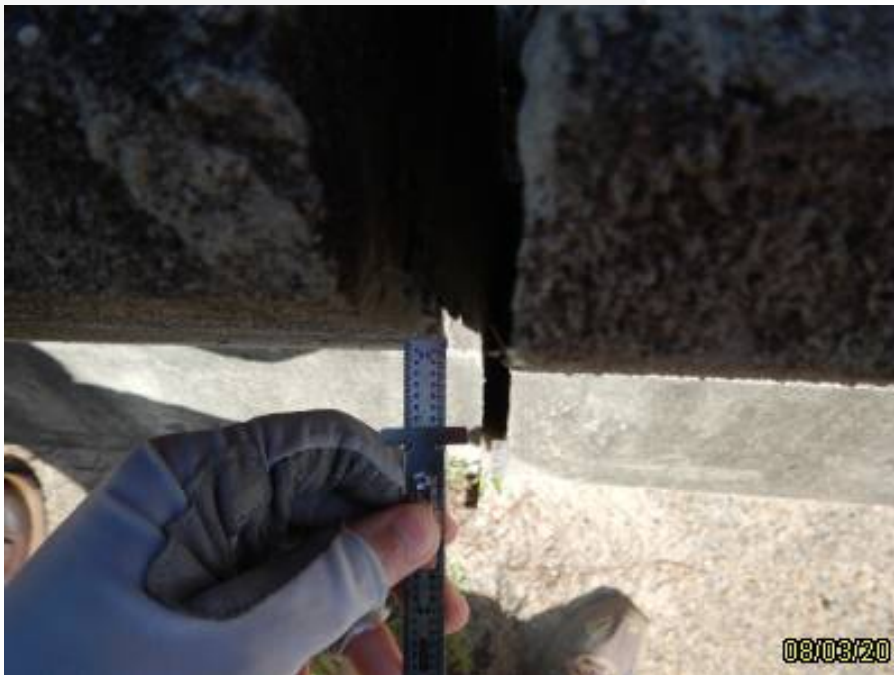
Photo 4 – Horizontal Misalignment at Bent 13

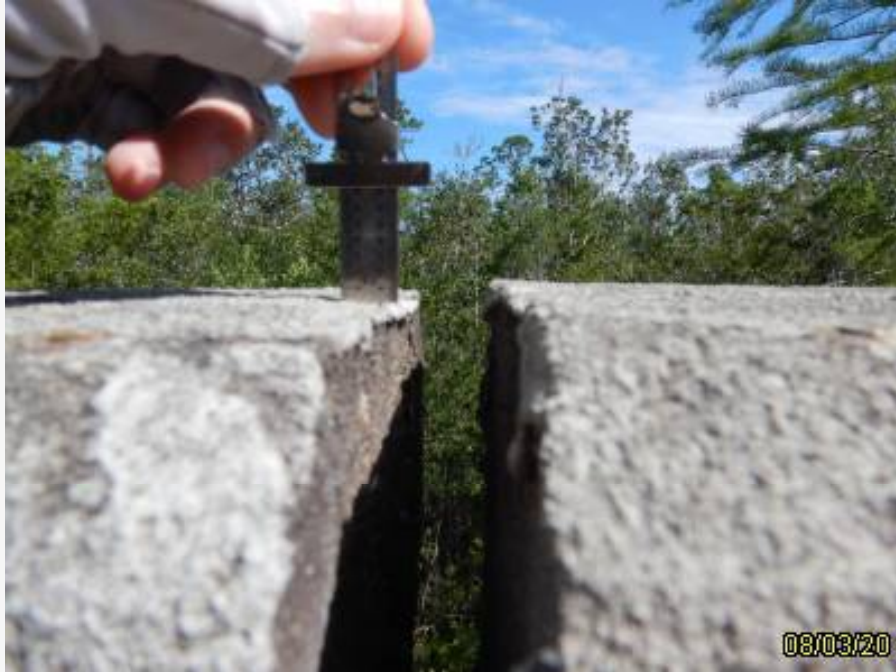
Photo 5 – Bridge Rail Vertical Alignment at Bent 43
