TO: ALL BIDDERS  
PROJECT: ITB PW 66-21 – College Road Bypass Bridge (No. 574132)  
Repairs

**Inspection/CIDR Report with PDF attachment(s)  
(INTERIM INSPECTION REPORT)**

Structure ID: 574132

STRUCTURE NAME: Not recorded  
YEAR BUILT: 1997  
SECTION NO.: 57 507 001  
MP: 1.619  
ROUTE: 00000  
FACILITY CARRIED: College Rd Bypass  
FEATURE INTERSECTED: Turkey Creek

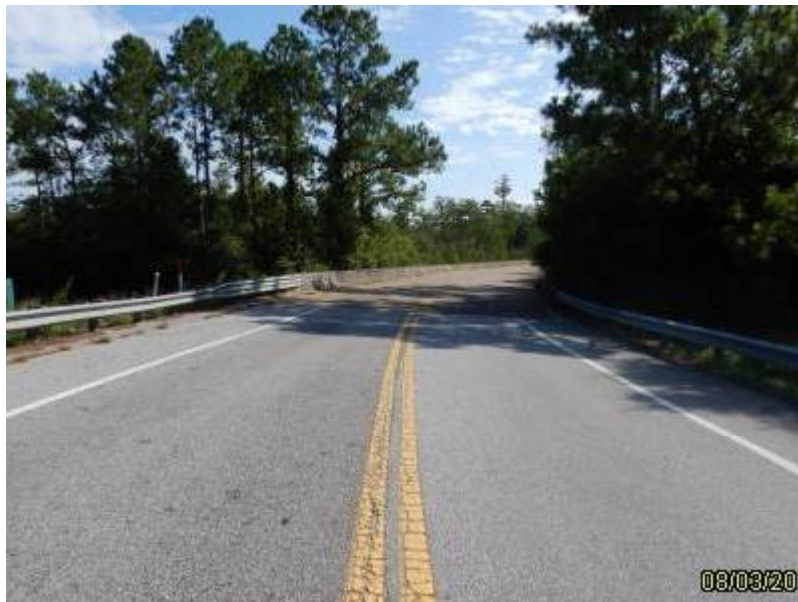
**Photo 10 - Element 8099 PS Conc Slab (Sonovoid) (510 Wearing Surfaces)**

1) The asphalt overlay has longitudinal cracks, up to 0.25in. wide, that coincide with the precast deck units (See Photo 10). (3822SF)

Typical longitudinal crack with the asphalt breaking apart

REPAIR RECOMMENDATION:  
See Photo 10.
